Monitoring Culvert Insulation The Dempster Highway, YT

Dempster Highway - Culvert Monitoring

- Monitor the impact of a newly installed culvert on permafrost
- Assess the efficiency a foam insulating layer

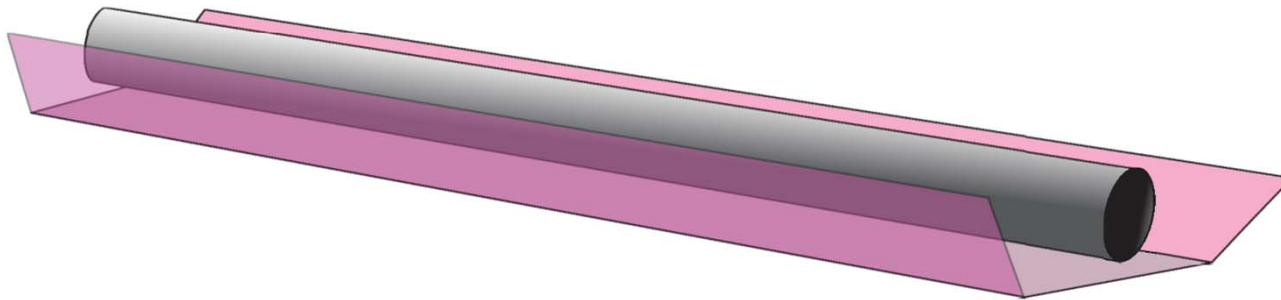
Culvert Monitoring - Setup

North

South

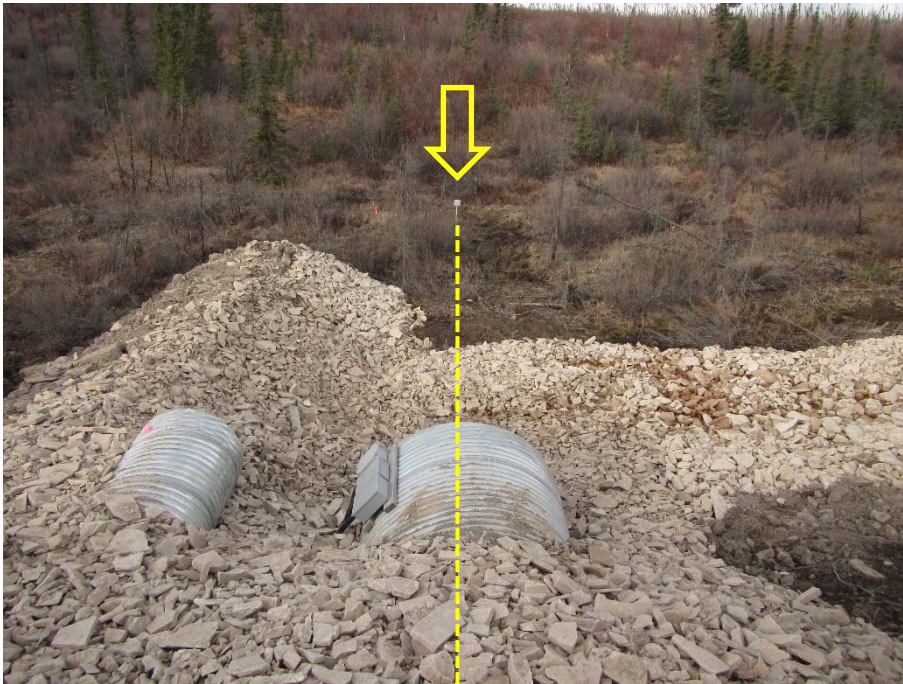
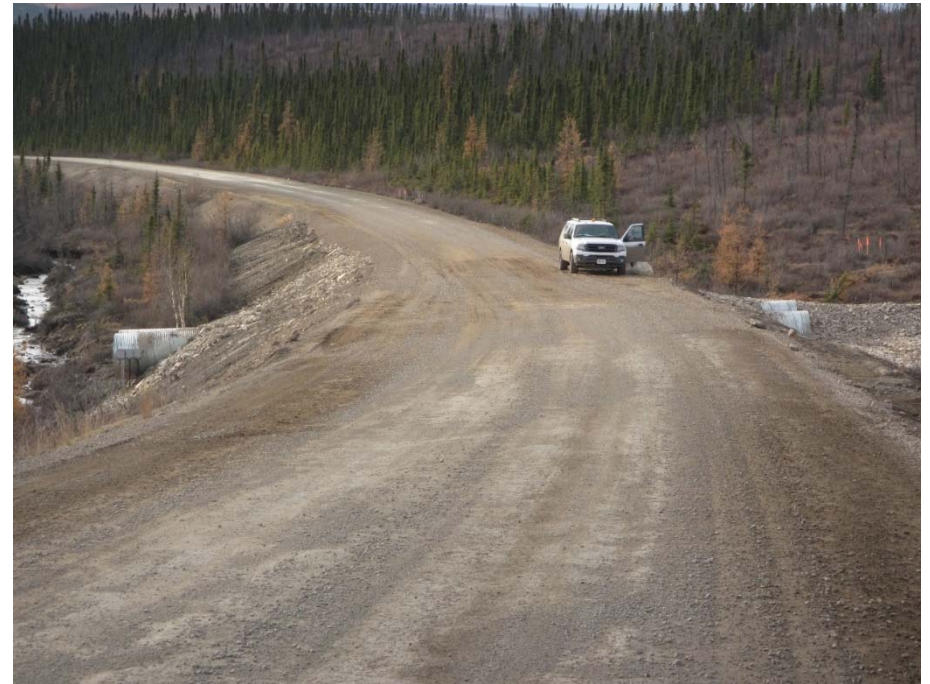
Field ground temperature

- 4.55 m temperature borehole aligned with the culvert and ERT array

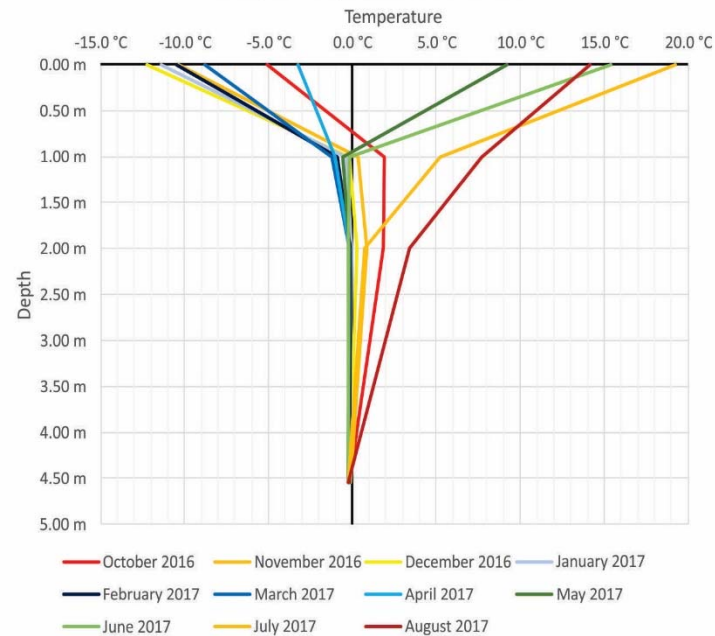
Ground temperature at km 381

Depth	2016			2017							
	October	November	December	January	February	March	April	May	June	July	August
0.00 m	-5.1 °C	-10.4 °C	-12.2 °C	-11.4 °C	-10.5 °C	-8.8 °C	-3.3 °C	9.2 °C	15.4 °C	19.2 °C	14.2 °C
1.00 m	1.9 °C	0.4 °C	-0.2 °C	-0.4 °C	-0.9 °C	-1.2 °C	-1.0 °C	-0.6 °C	-0.2 °C	5.2 °C	7.7 °C
2.00 m	1.8 °C	0.9 °C	0.3 °C	0.0 °C	-0.1 °C	-0.2 °C	-0.2 °C	-0.2 °C	-0.2 °C	0.7 °C	3.4 °C
4.55 m	-0.2 °C	-0.1 °C	-0.2 °C	-0.2 °C	-0.2 °C	-0.2 °C	-0.2 °C	-0.2 °C	-0.2 °C	-0.2 °C	-0.2 °C

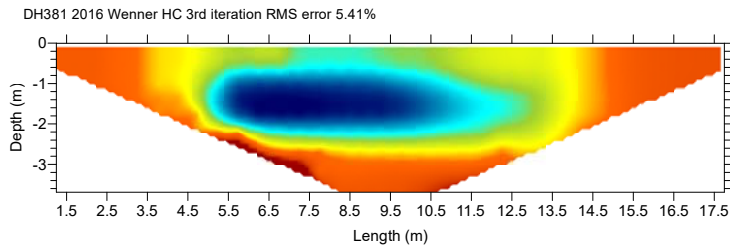
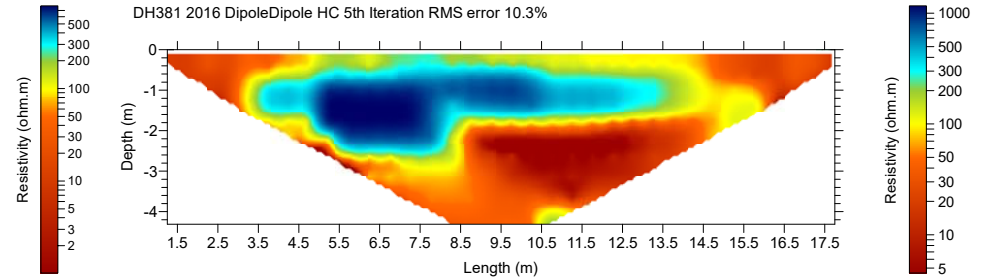
Sept.
2016

Electrical Resistivity Tomography

Wenner

Dipole-dipole

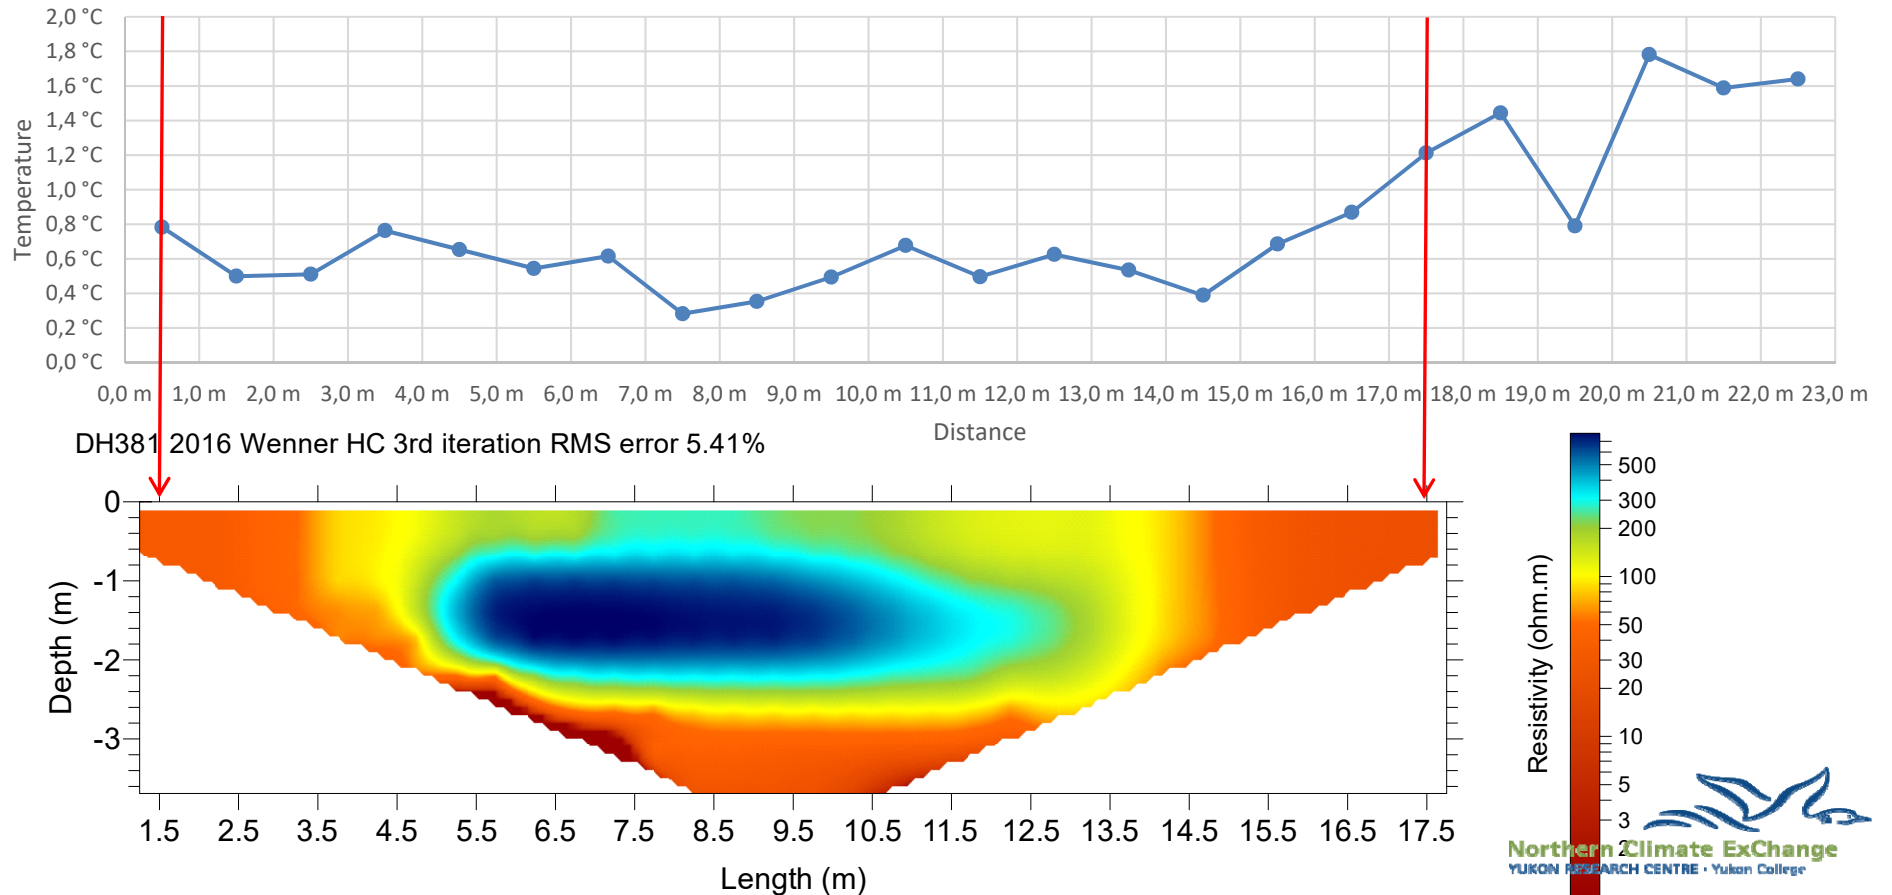
Electrical Resistivity Tomography & Temperature

Temperature between electrodes - 12PM September 29th 2016

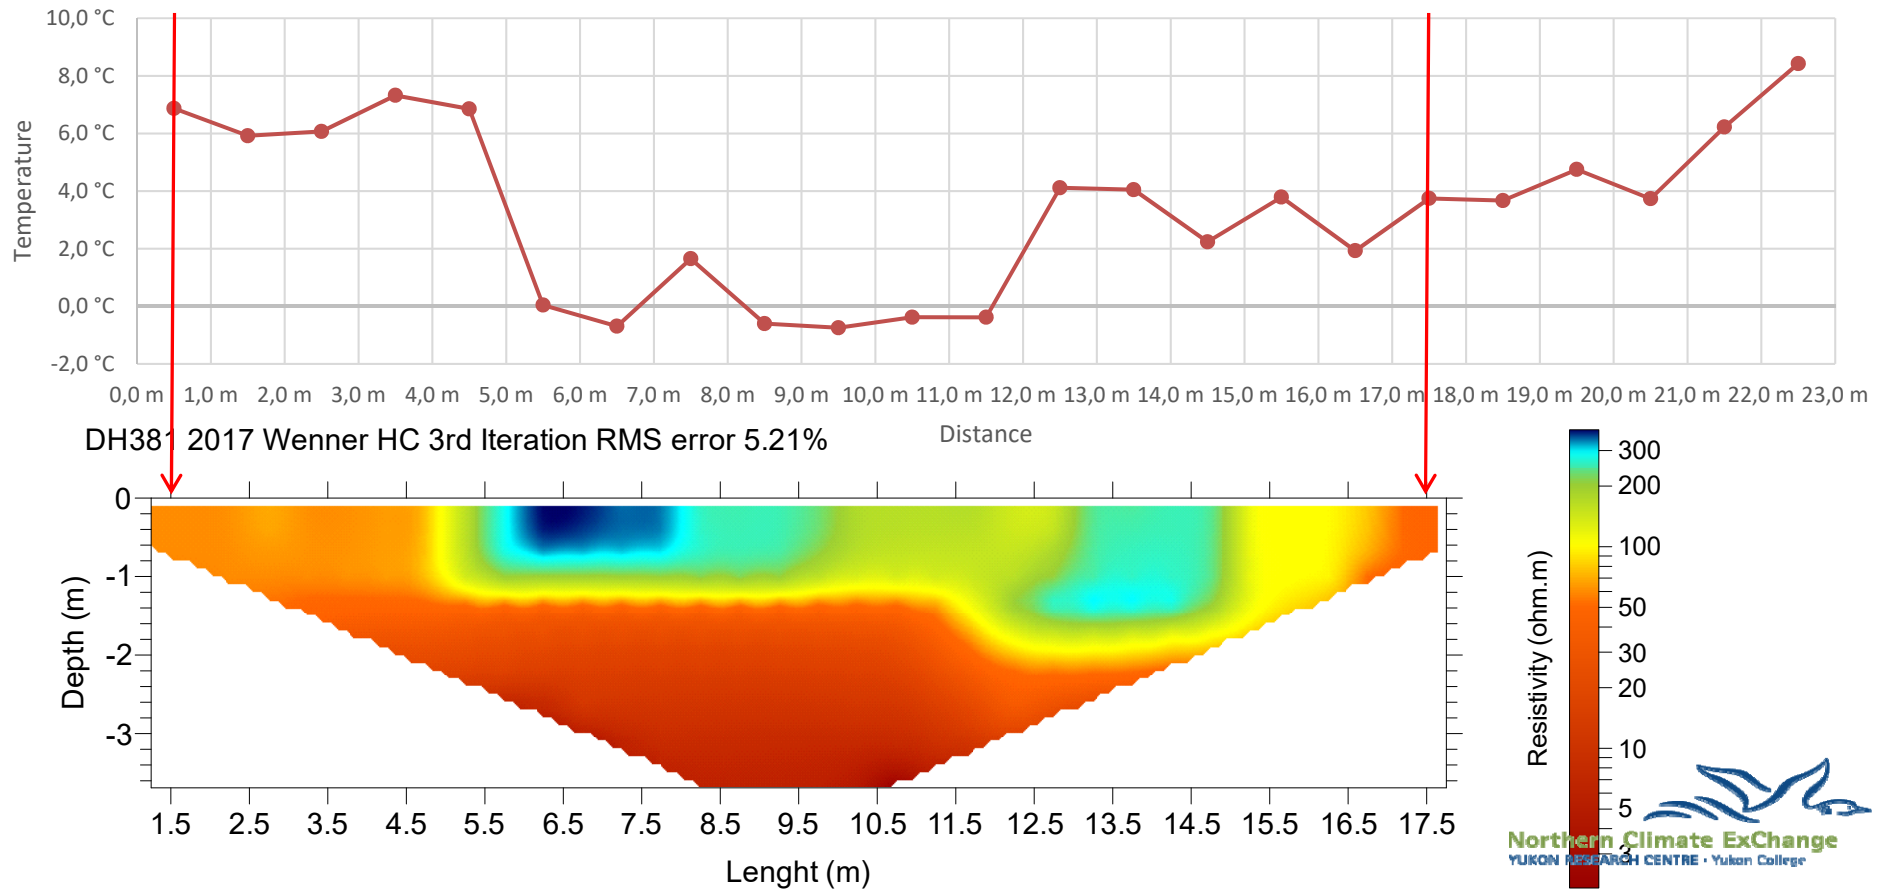
Electrical Resistivity Tomography & Temperature

Temperature between electrodes - 14PM June 30th 2017
